Contract #: 04-0120F4Cty: SF/ALA Rte: 80 PM: 13.2/13.9File #: 99.28**WELDING INSPECTION REPORT****Resident Engineer:** Casey, William**Address:** 333 Burma Road**City:** Oakland, CA 94607**Report No:** WIR-029722**Date Inspected:** 18-Jun-2013**Project Name:** SAS Superstructure**OSM Arrival Time:** 700**Prime Contractor:** American Bridge/Fluor Enterprises, a JV**OSM Departure Time:** 1530**Contractor:** USA Hoist**Location:** Crest Hill, IL

Component: SAS Tower Elevator

Bridge No: 34-0006**Summary of Items Observed:**

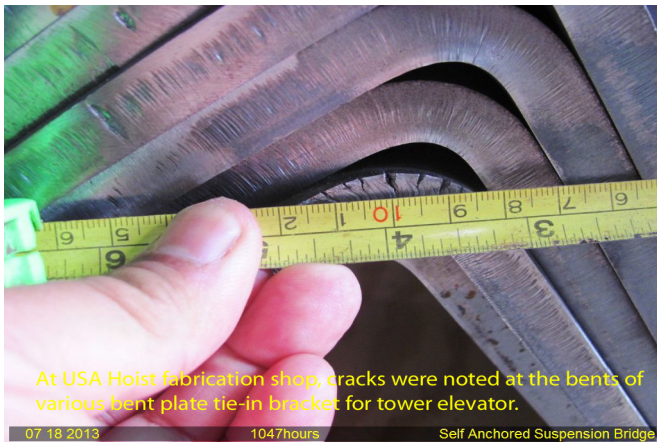
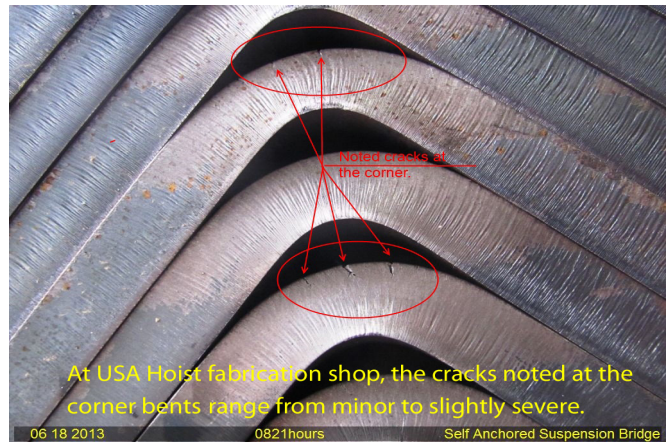
During the shift and inspection rounds of this QA, it was noted that some of the bent plate tie-in brackets are showing some cracks at the corner where the bent is. This issue was immediately brought to the attention of USA Hoist Project Engineer Bob Overbeek who came and saw for himself the cracks. Mr. Overbeek then informed this QA that they intend to grind and remove the cracks and if there is anything that shows up bad then USA will discard them but did not mention what to do after grinding. This QA took some photographs and sent them to Caltrans SMR Tim Truong and METS Supervisor Mike Foerder for information. Mr. Tim Truong communicated with this QA thru e-mail and telephone conversation regarding the bent plate tie-in bracket issue. He also mentioned during the conversation that USA Hoist can grind the cracks to 1/8" and will ask them (USA HOIST) to perform Magnetic Particle Testing (MT). An Incident Report was initiated due to the cracks that were noted on some of the various bent plate brackets.

The crack issue on various bent plate brackets was brought to the attention of USA Hoist Project Engineer Bob Overbeek. During the conversation, he mentioned to this QA that USA Hoist will grind remove the cracks on the brackets and if there are cracks on the brackets that are bad USA Hoist will discard them.

Caltrans SMR Tim Truong also informed this QA that USA Hoist can grind up to 1/8" to remove the cracks. He also mentioned that he will ask USA Hoist to perform MT on all bent plate brackets.
